HERITAGE COUNCIL OF WESTERN AUSTRALIA

CONSERVATION PLAN DONNELLY RIVER MILL

MARCH 1994

G B HILL & PARTNERS PTY LTD
62 COLIN STREET
WEST PERTH WA 6005

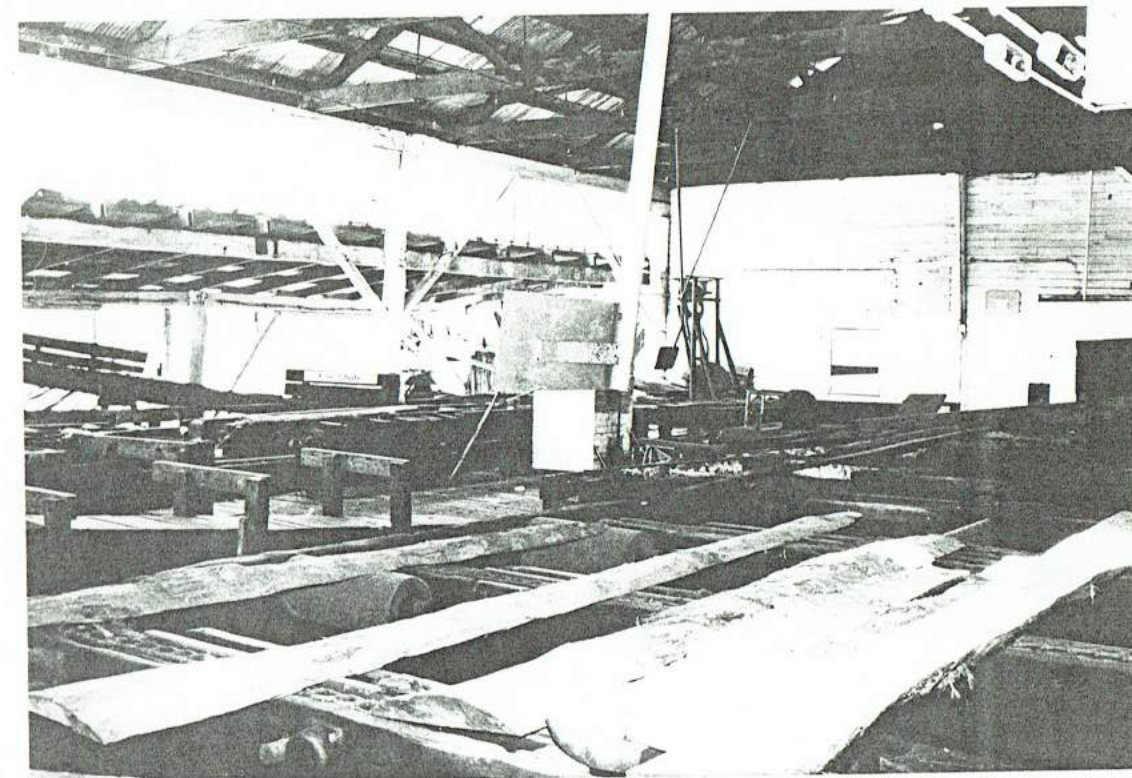
EXISTING
50. Power Roller And Chains For Movement Of Timber From No. 1 Saw Bench. 1994

Timber from the No. 1 saw bench was unloaded from the rail mounted trolley onto powered chains, which moved the timber sideways to the north onto rollers for either movement to the No. 1 docker and to the storage yard or No. 2 saw bench or further east for further sideways movement to the north for loading onto the rail trolley for entry to No. 3 saw bench (Refer plan Appendix 4). The power chains and rollers are shown on Photo 50 and Photo 24.

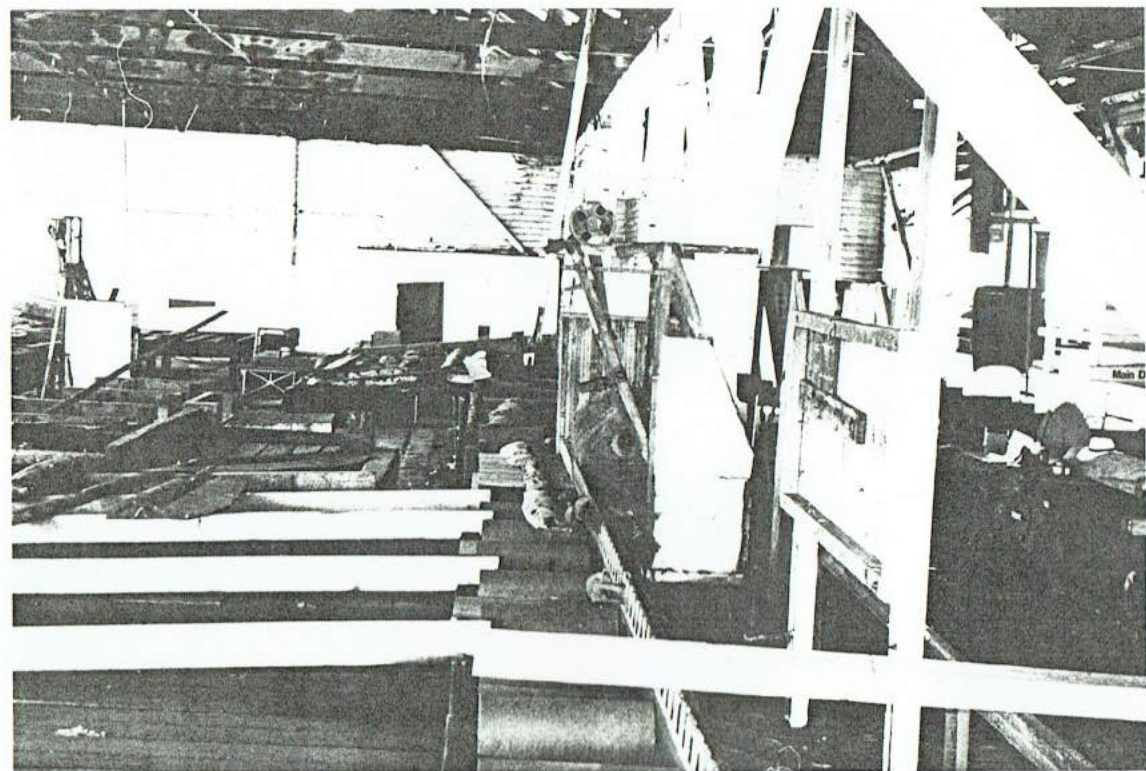
EXISTING
51. No. 1 Docker Saw. 1994

Photo 51 shows the saw and rollers for movement of the timber either to the storage yard or sideways onto the skids leading to No. 2 saw bench.

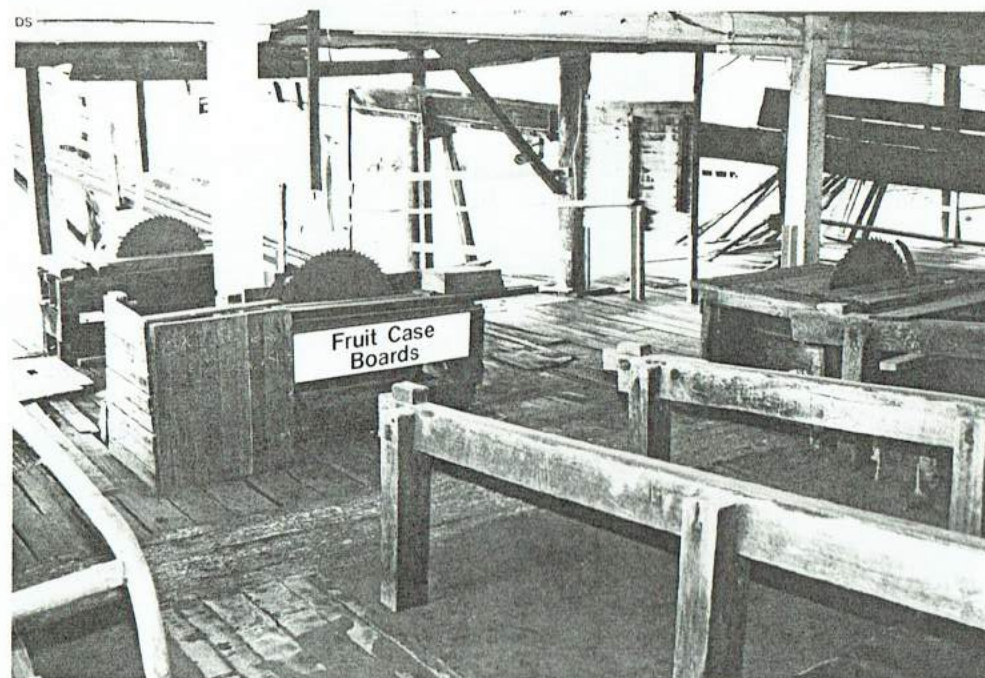
EXISTING
55. Fruit Case Saws. 1994

This area is located under the annex roof on the northern extension of the mill floor. (Photo 55)

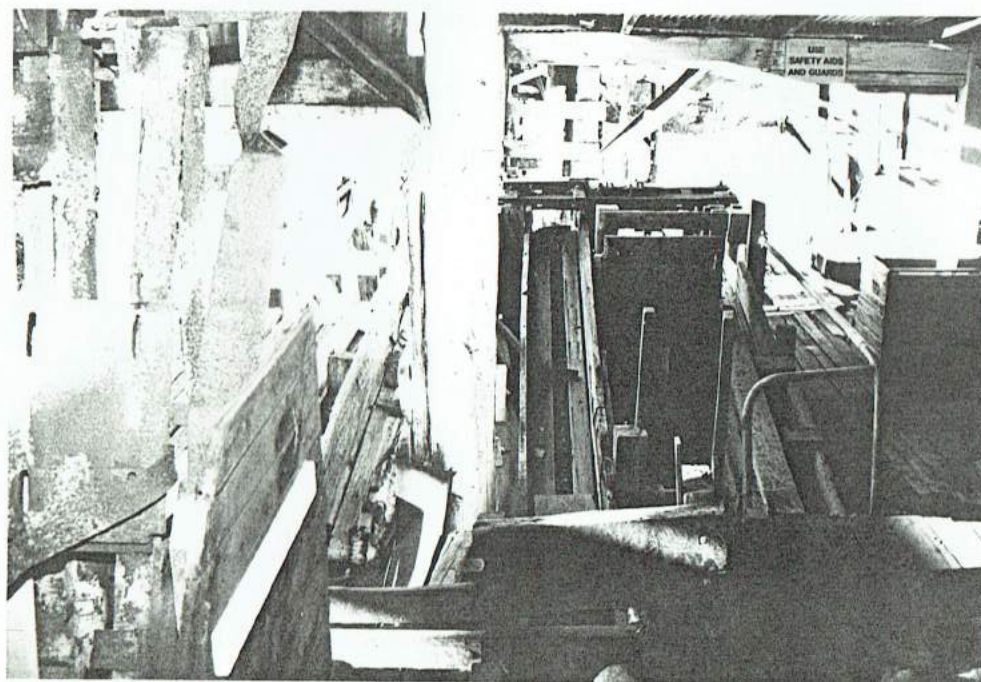
EXISTING
56. Under Floor Conveyors From No. 1 Docker To Fruit Case Area And Waste Chute (Left Side Of Photo).

Three saws are located in this area with the smaller sized timber being moved into the area from the No. 1 docker along the inclined conveyor under the mill floor. (Photo 56)

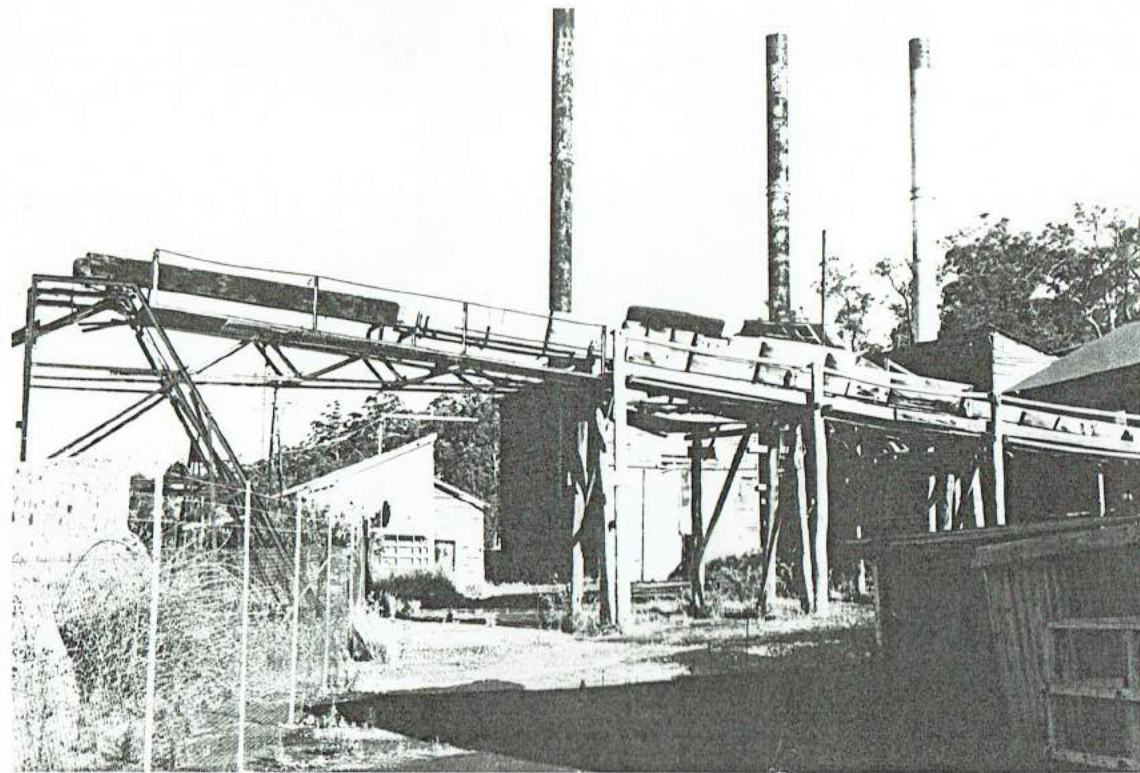
EXISTING
58. Conveyor Support Structure And Fire Hole.

Photo 25 shows the fire hole in operation and photo 58 shows the support structure for the conveyors to the fire hole.

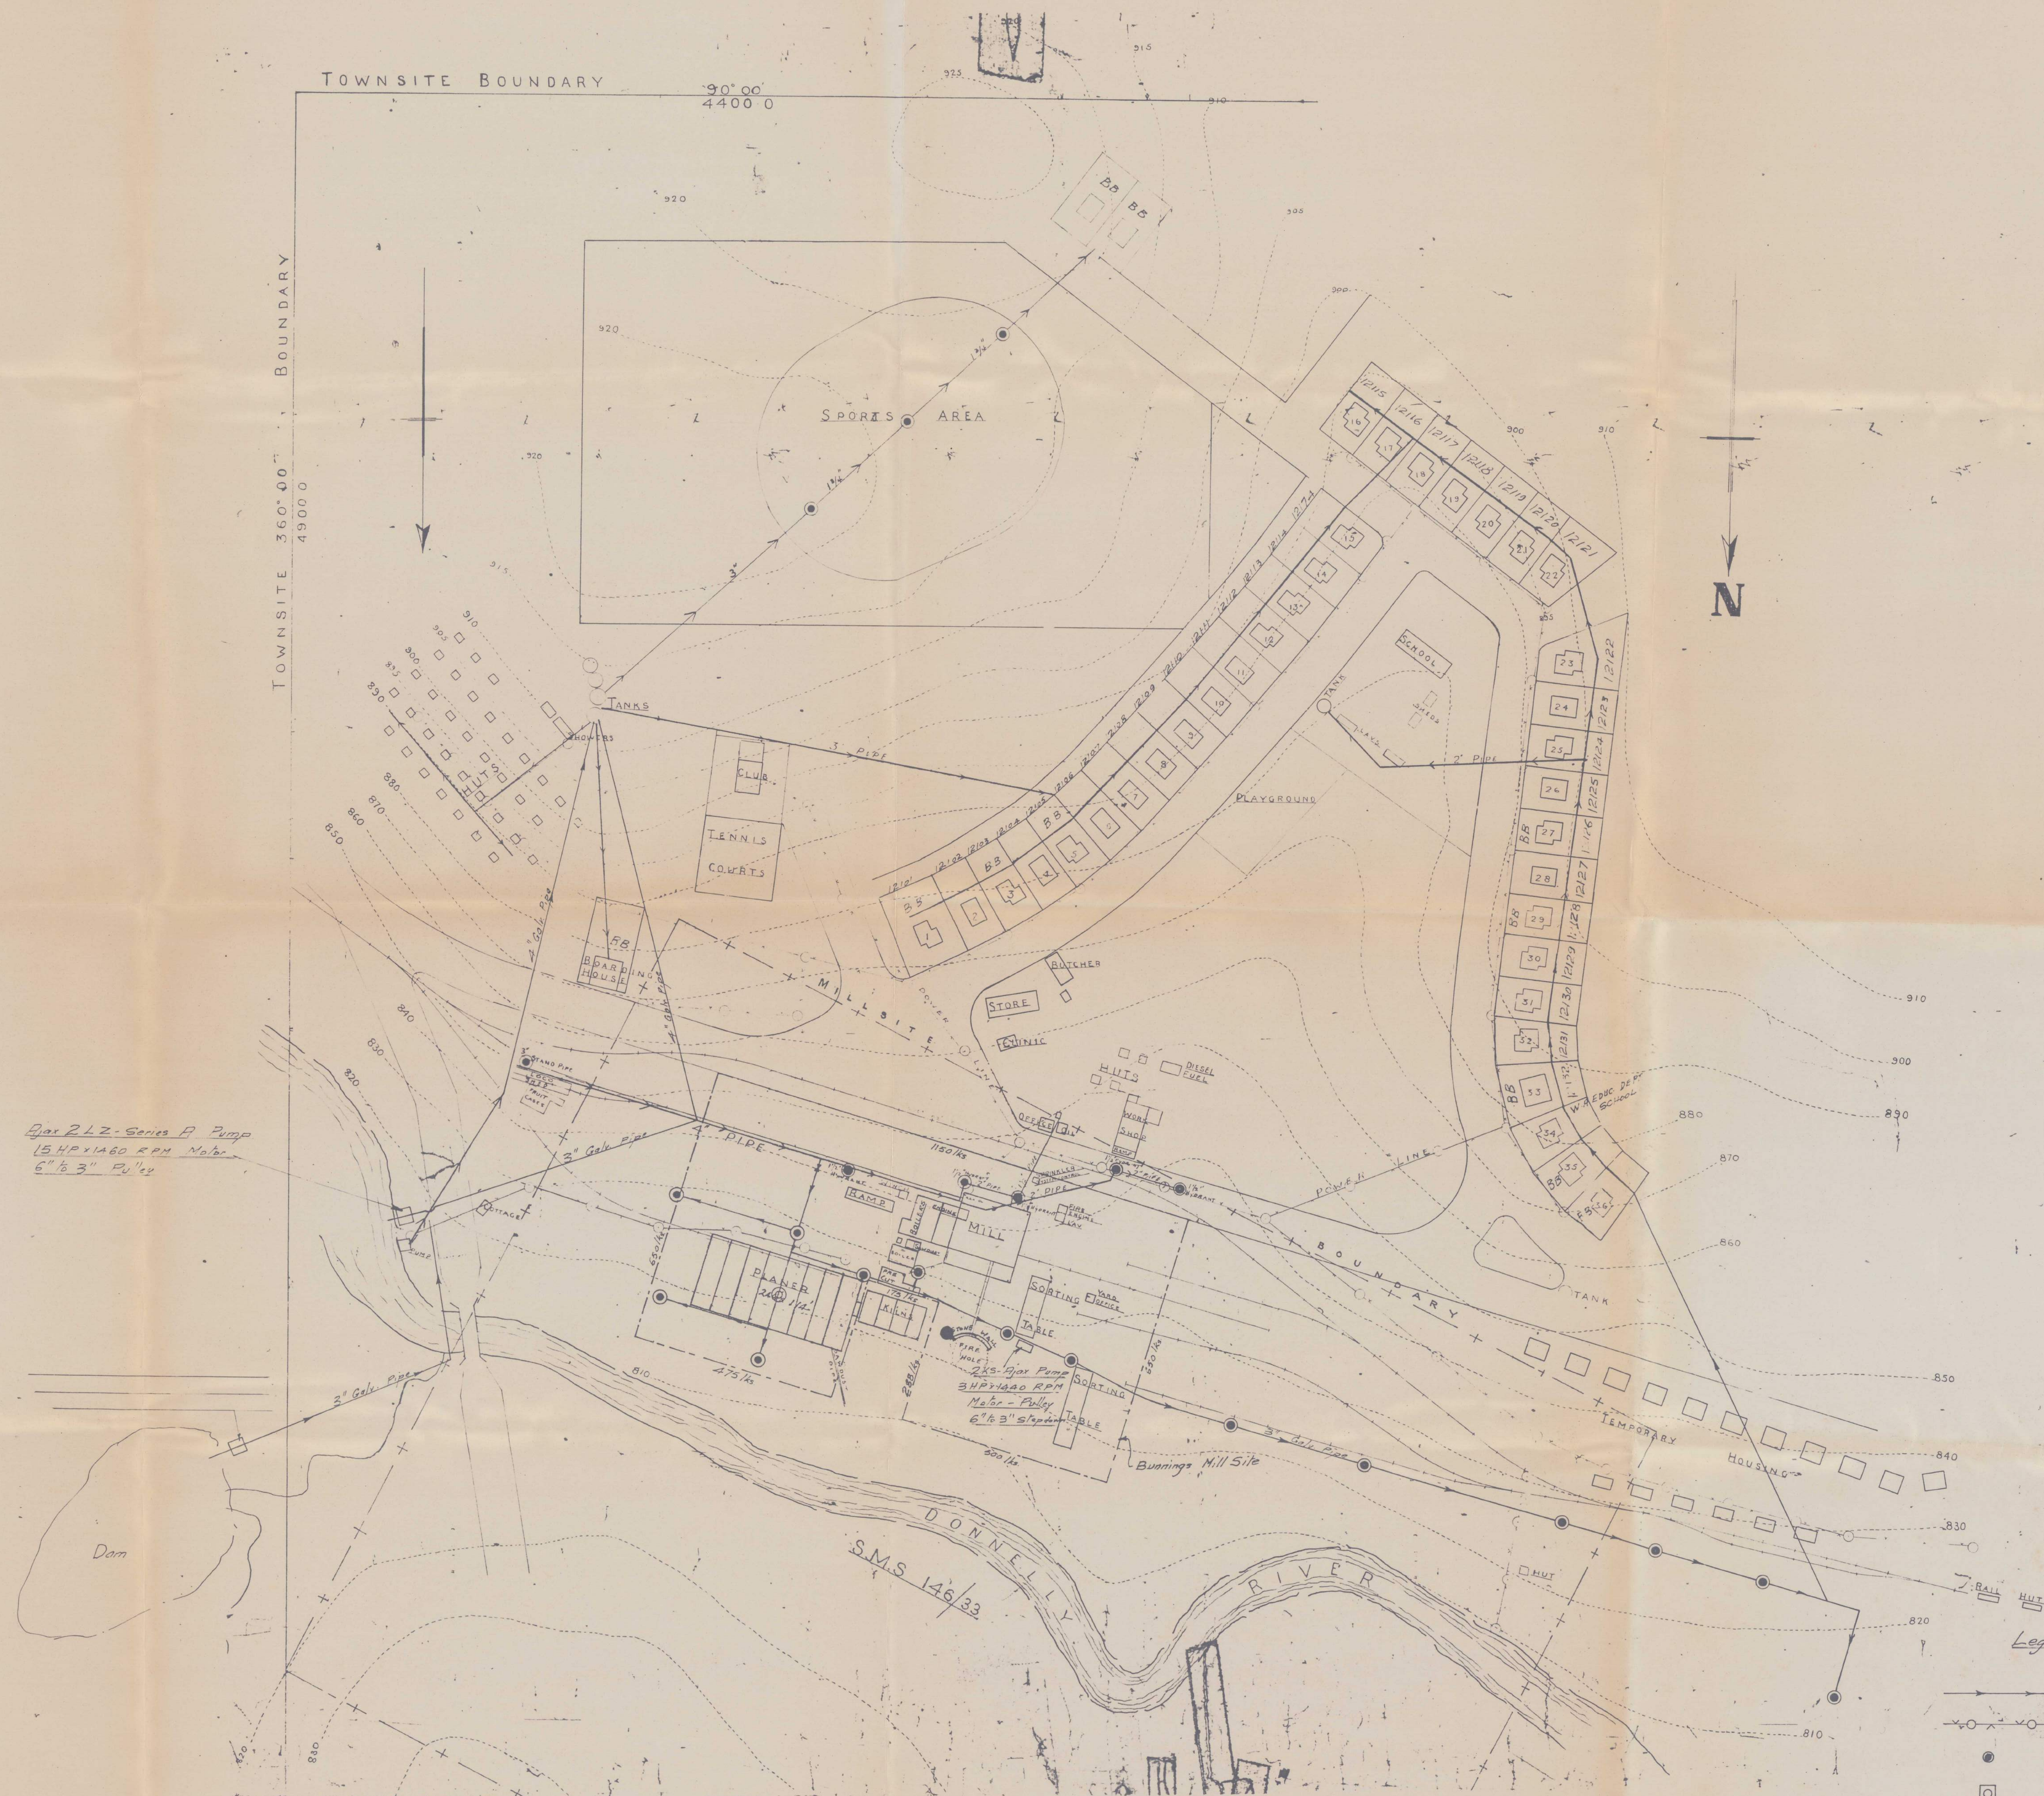
Mill Site Layout, Bunnings Plan 10531

Plan 10531 in Appendix 2 indicates the rail line system used to move timber in the storage yard.
